## Resolving “empty tray” message.

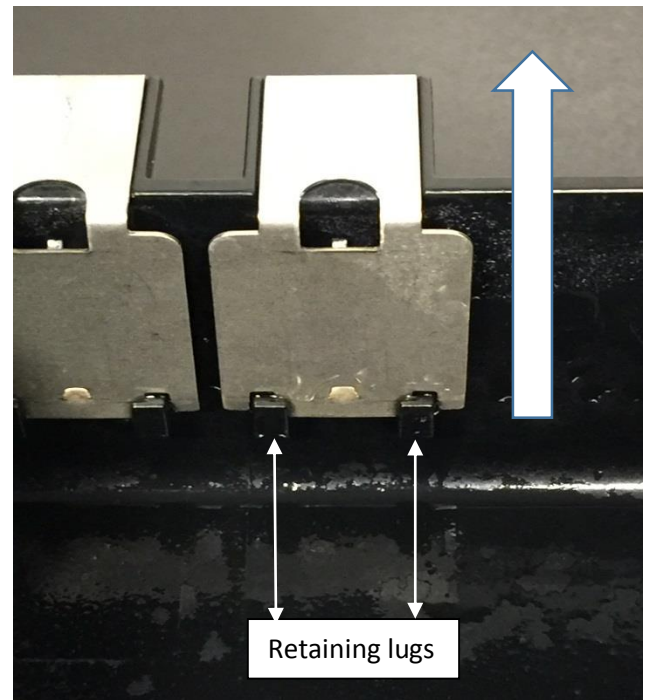
The right hand contact as shown in the top picture will need to be removed so we can clean any coffee residue from behind it, **the left hand contact does not need removing.**

Using a small screwdriver or blade we need to carefully push the contact straight up.

**Do not pull the contact towards you as this can damage the 2 black plastic retaining lugs.**

The metal contact is held firmly in place by the black plastic lugs so a small amount of effort is required to move it up from behind them.

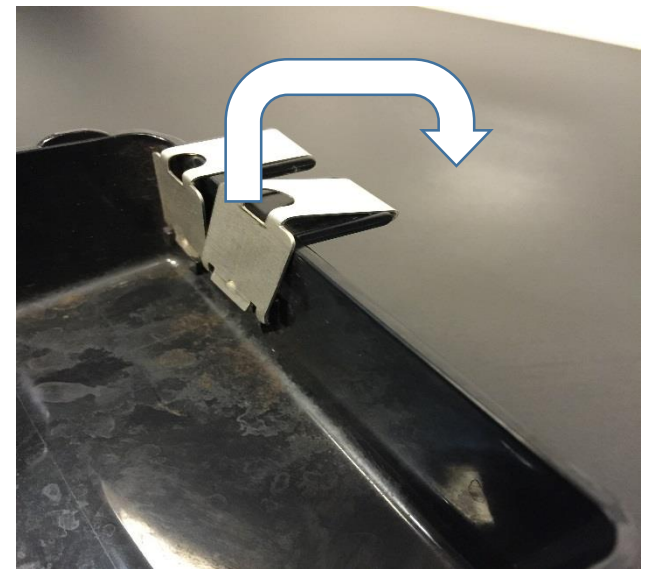
Once the contact is no longer behind the black plastic lugs as shown in the middle picture, you can lift it up and away from you to release it.

To re-assemble, hook the contact over the back of the horizontal black tab as shown in the middle picture and push behind the lugs.

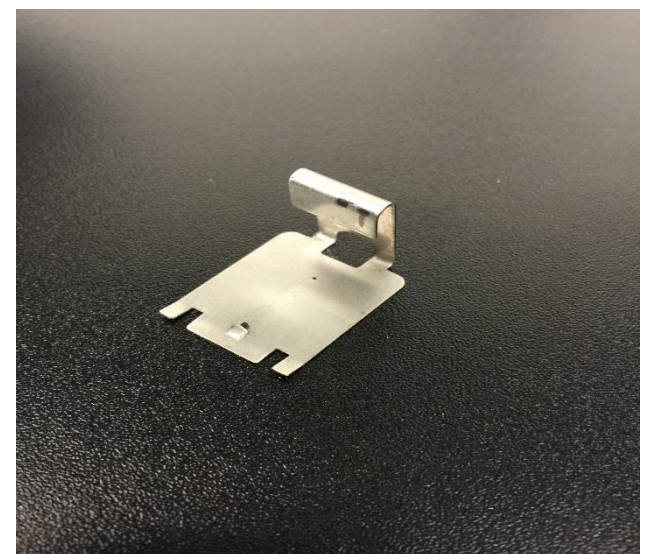
The contact and the plastic tray behind it can now be cleaned and dried to remove any coffee or dirt as shown in the bottom picture.
